Manhole Inspection Summary

Manhole # S41QQ_023MH

Insp Date: **4/12/07 1:22 PM**

Location Address: **2511 AISQUITH AVE**

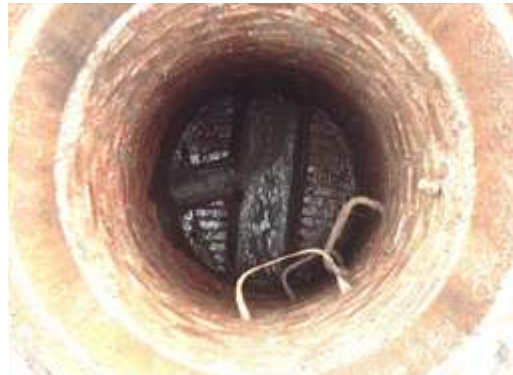
Top View

Corroded steps. Bench debris.

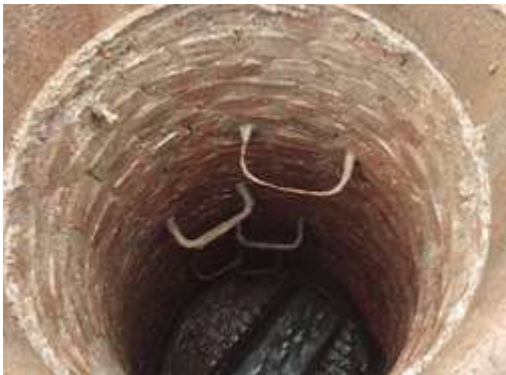
Defect

☒ **Leaks**

Condition: ☐ Sound ☐ Cracked ☐ Root Intrusion ☐ Loose Brick ☒ **Deteriorated**

Infiltration: ☐ None ☒ **Joint** ☐ Cracks ☐ Mortar ☐ Roots ☒ **Wall**

Frame leaks. Adjustment deterioration and infiltration. Barrel infiltration.

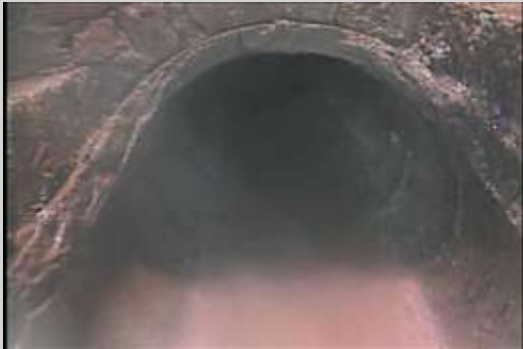
20 in. Circular Gravity Sewer Pipe Out @ 12 O'Clock

Infiltration: **None** Pipe Seal Cond: **Cracked**

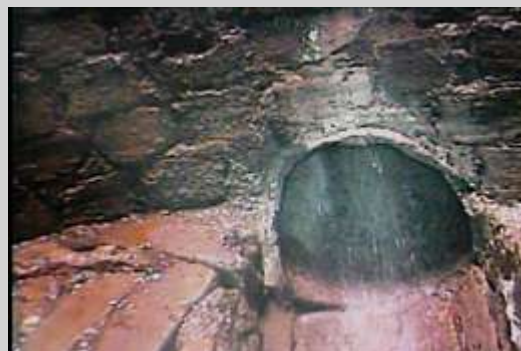
Drop In @ 9 O'Clock

Barrel deterioration and infiltration. Bench and Channel deterioration.
